## COMMERCIAL WINDSTORM MITIGATION INSPECTION REPORT (OIR-B1-1802)

East Lake Woodlands Woods Landing Townhomes Unit One  
Association, Inc.

30-60 Woods Landing Trail (Building 1)  
Oldsmar, FL 34677

As of 3/5/2014

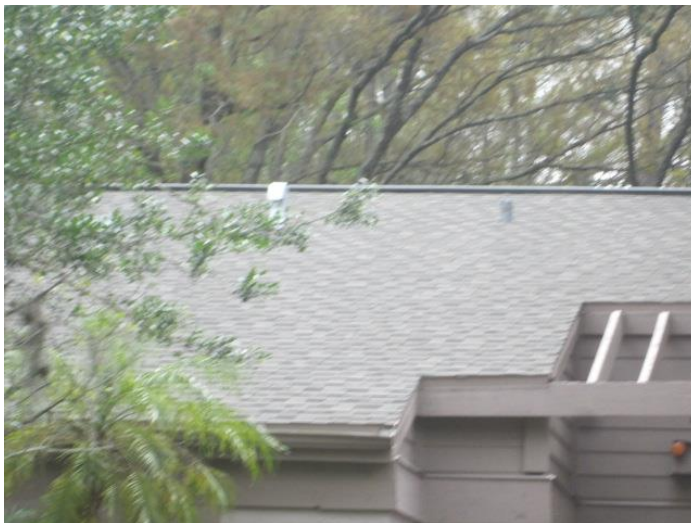
Roof Covering

- 2. Roof Covering:**                      **FBC Equivalent**  
Comments:                                      The roof covering was replaced in 2013. The roof permit was confirmed and the permit number is CW13-07671. This roof was verified as meeting the building code requirements outlined on the mitigation affidavit.

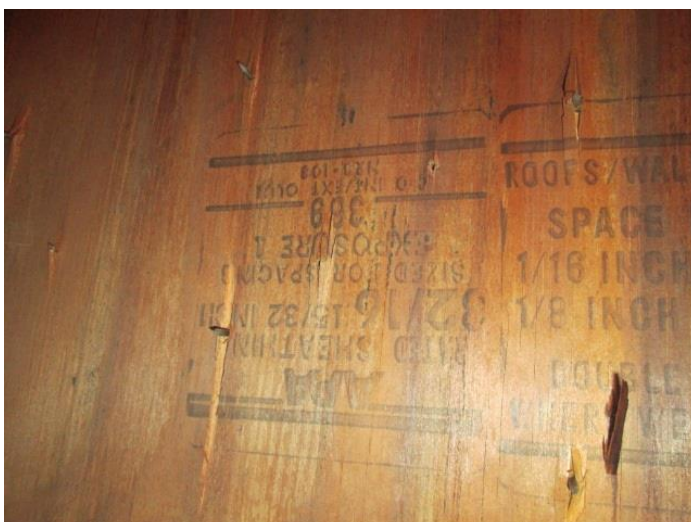
Roof Deck Material

- 3. Roof Deck Attachment:**        **Level C**  
Comments:                                      Inspection verified 1/2" plywood roof deck attached with 8d nails at a minimum 6" on the edge & 6" in the field.

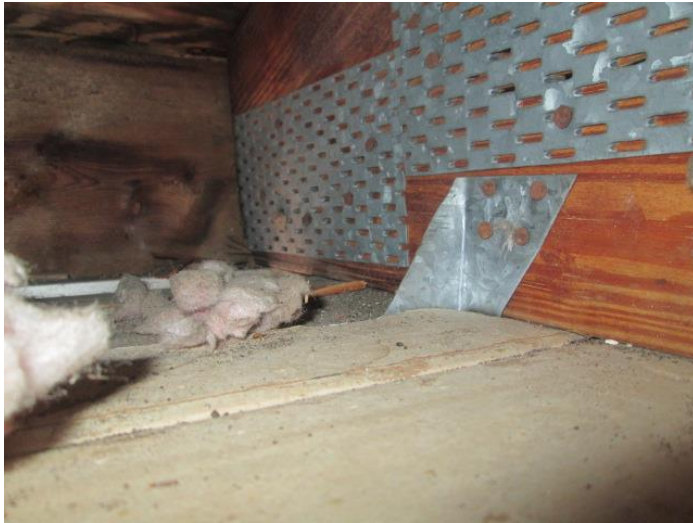
Roof to Wall Attachment

- 4. Roof to Wall Attachment:**        **Clips**  
Comments:                                      Inspection verified hurricane clips fastened with a minimum of three nails.

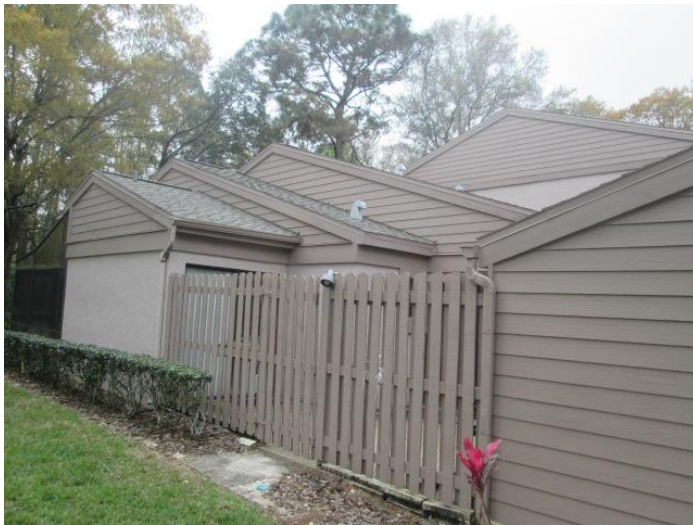
Roof Shape

- 5. Roof Geometry:**                      **Other Roof**  
Comments:                                      Inspection verified a gable roof shape.
- 6. SWR:**                                      **Yes**  
Comments:                                      SWR was verified at time of inspection. The Secondary Water Resistance verified is a self-adhering peel and stick.
