COMMERCIAL WINDSTORM MITIGATION INSPECTION REPORT (OIR-B1-1802)

East Lake Woodlands Woods Landing Townhomes Unit One
Association, Inc.

295-375 Woods Landing Trail (Building 10)
Oldsmar, FL 34677

As of 3/5/2014

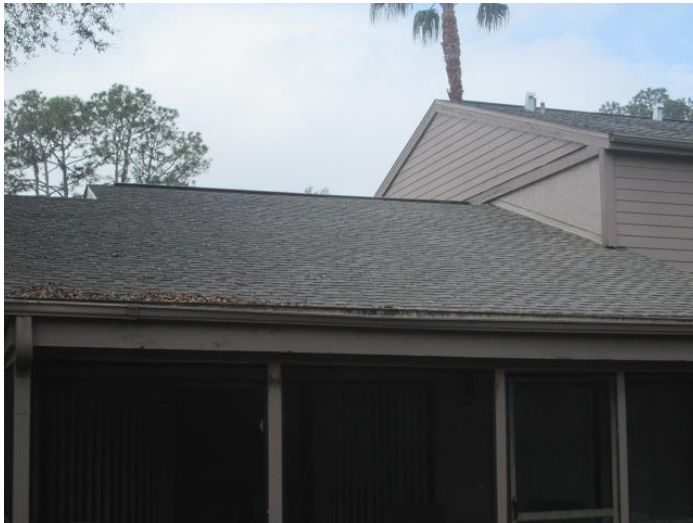
Roof Covering

- 2. Roof Covering:** **FBC Equivalent**
Comments: The roof covering was replaced in 2013. The roof permit was confirmed and the permit number is CW13-10640. This roof was verified as meeting the building code requirements outlined on the mitigation affidavit.

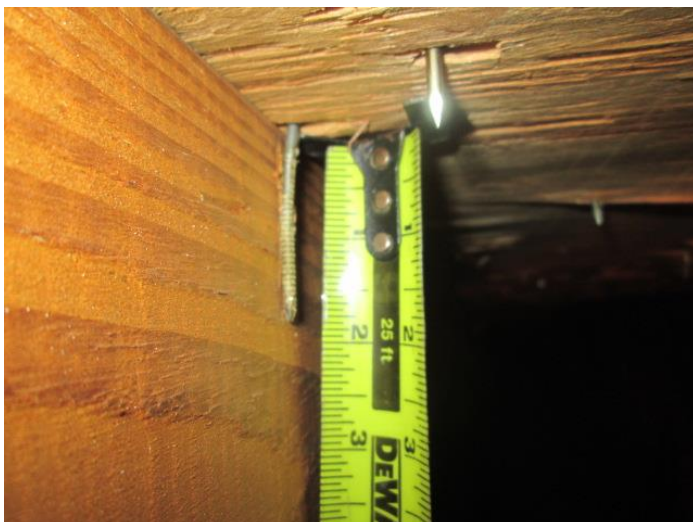
Roof Deck Attachment

- 3. Roof Deck Attachment:** **Level C**
Comments: Inspection verified 1/2" plywood roof deck attached with 8d nails at a minimum 6" on the edge & 6" in the field.

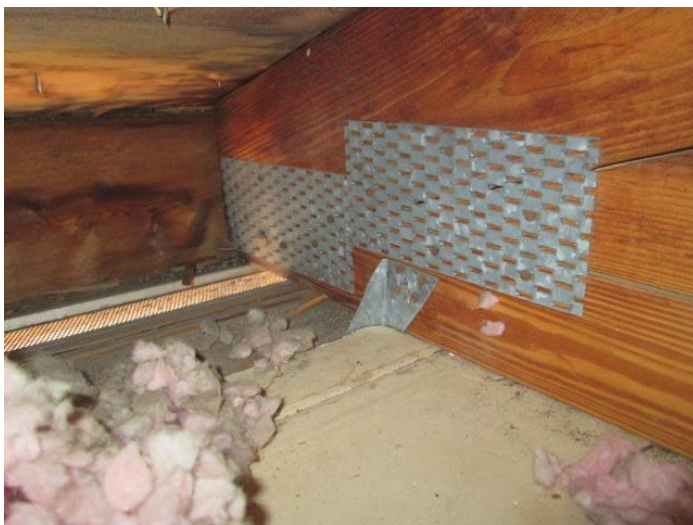
Roof to Wall Attachment

- 4. Roof to Wall Attachment:** **Clips**
Comments: Inspection verified hurricane clips fastened with a minimum of three nails.
- 5. Roof Geometry:** **Other Roof**
Comments: Inspection verified a gable roof shape.
