## COMMERCIAL WINDSTORM MITIGATION INSPECTION REPORT (OIR-B1-1802)

### East Lake Woodlands Woods Landing Townhomes Unit One Association, Inc.

340 Woods Landing Trail, 10-50 Landings Way (Building 12)  
Oldsmar, FL 34677

As of 3/5/2014

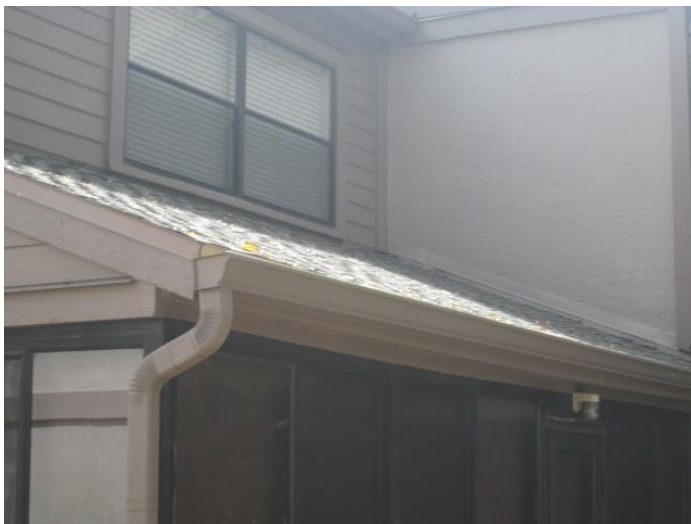
Roof Covering

2. **Roof Covering:**                        **FBC Equivalent**  
Comments:                                      The roof covering was replaced in 2013. The roof permit was confirmed and the permit number is CW13-06124. This roof was verified as meeting the building code requirements outlined on the mitigation affidavit.

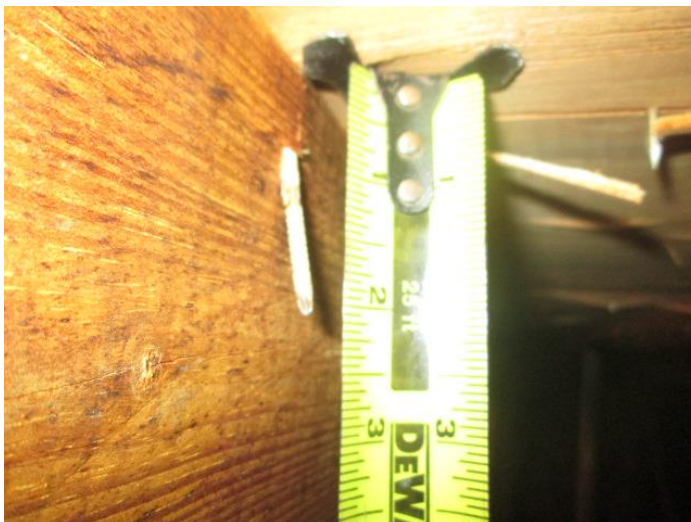
Roof Deck Attachment

3. **Roof Deck Attachment:**            **Level C**  
Comments:                                      Inspection verified 1/2" plywood roof deck attached with 8d nails at a minimum 6" on the edge & 6" in the field.

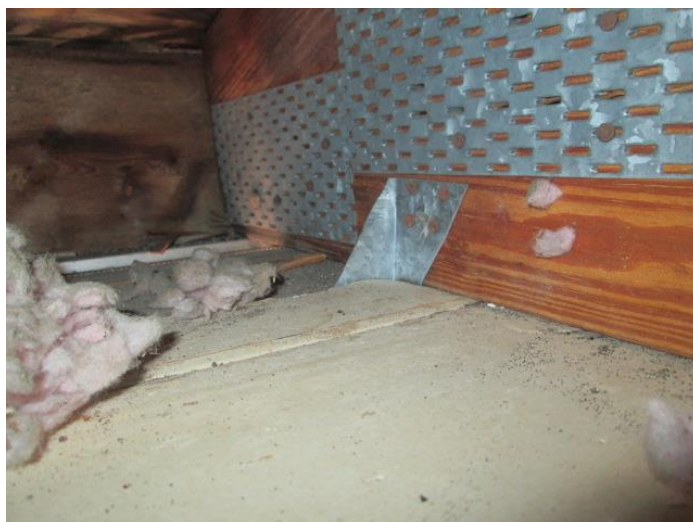
Roof to Wall Attachment

4. **Roof to Wall Attachment:**            **Clips**  
Comments:                                      Inspection verified hurricane clips fastened with a minimum of three nails.

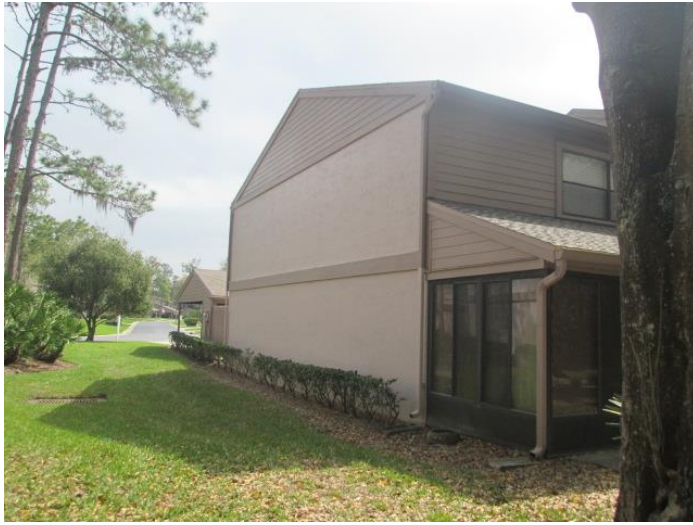
Roof Shape

5. **Roof Geometry:**                        **Other Roof**  
Comments:                                      Inspection verified a gable roof shape.
6. **SWR:**                                        **Yes**  
Comments:                                      SWR was verified at time of inspection. The Secondary Water Resistance verified is a self-adhering peel and stick.
