COMMERCIAL WINDSTORM MITIGATION INSPECTION REPORT (OIR-B1-1802)

East Lake Woodlands Woods Landing Townhomes Unit One
Association, Inc.

380-460 Woods Landing Trail (Building 13)
Oldsmar, FL 34677

As of 3/5/2014

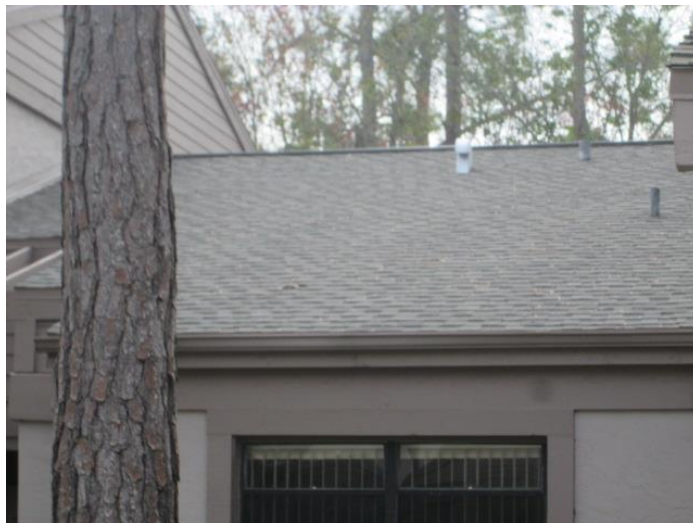
Roof Covering

2. **Roof Covering:** **FBC Equivalent**
Comments: The roof covering was replaced in 2013. The roof permit was confirmed and the permit number is CW13-09103. This roof was verified as meeting the building code requirements outlined on the mitigation affidavit.

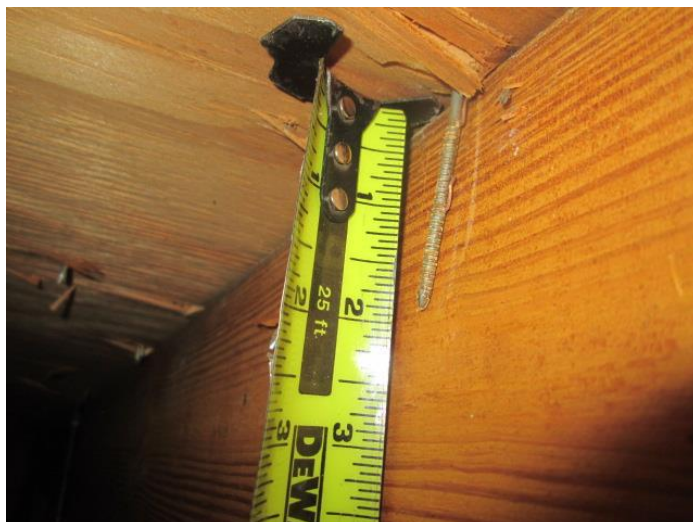
Roof Deck Attachment

3. **Roof Deck Attachment:** **Level C**
Comments: Inspection verified 1/2" plywood roof deck attached with 8d nails at a minimum 6" on the edge & 6" in the field.

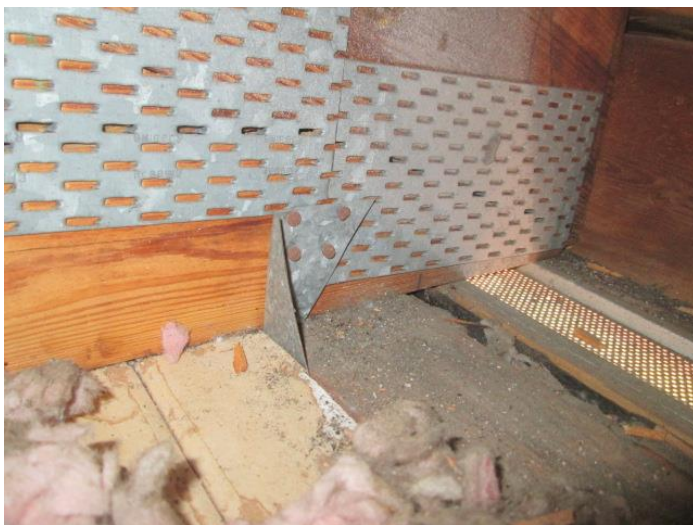
Roof to Wall Attachment

4. **Roof to Wall Attachment:** **Clips**
Comments: Inspection verified hurricane clips fastened with a minimum of three nails.
5. **Roof Geometry:** **Other Roof**
Comments: Inspection verified a gable roof shape.
