## COMMERCIAL WINDSTORM MITIGATION INSPECTION REPORT (OIR-B1-1802)

East Lake Woodlands Woods Landing Townhomes Unit One  
Association, Inc.

385-445 Woods Landing Trail (Building 14)  
Oldsmar, FL 34677

As of 3/5/2014

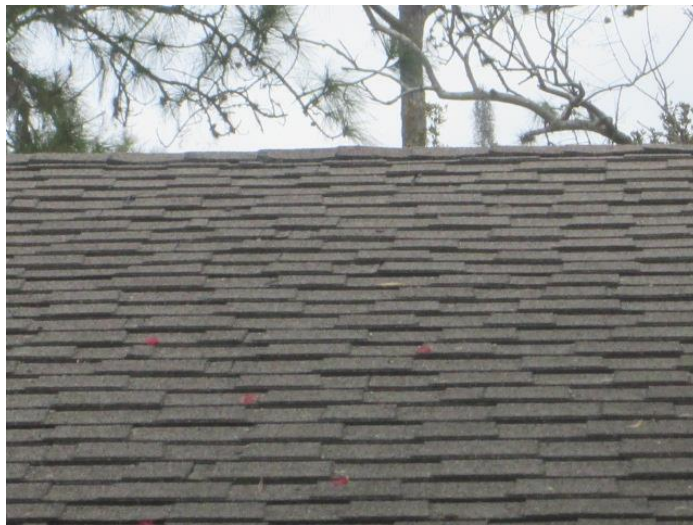
Roof Covering

2. **Roof Covering:**                      **FBC Equivalent**  
Comments:                                      The roof covering was replaced in 2014. The roof permit was confirmed and the permit number is CW14-01386. This roof was verified as meeting the building code requirements outlined on the mitigation affidavit.

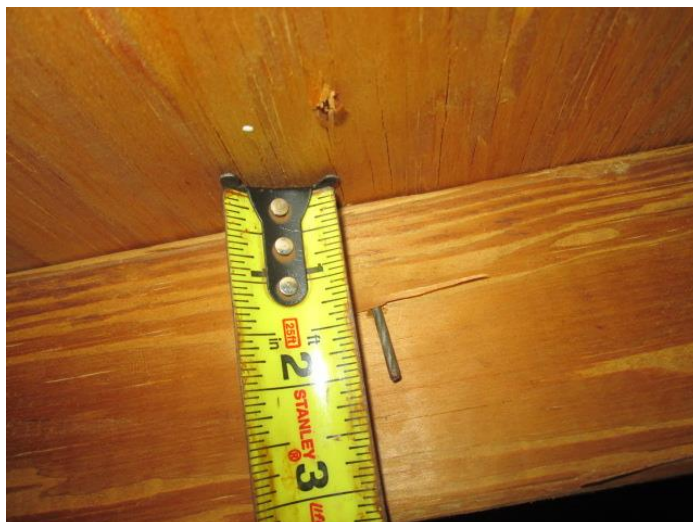
Roof Deck Attachment

3. **Roof Deck Attachment:**        **Level C**  
Comments:                                      Inspection verified 1/2" plywood roof deck attached with 8d nails at a minimum 6" on the edge & 6" in the field.

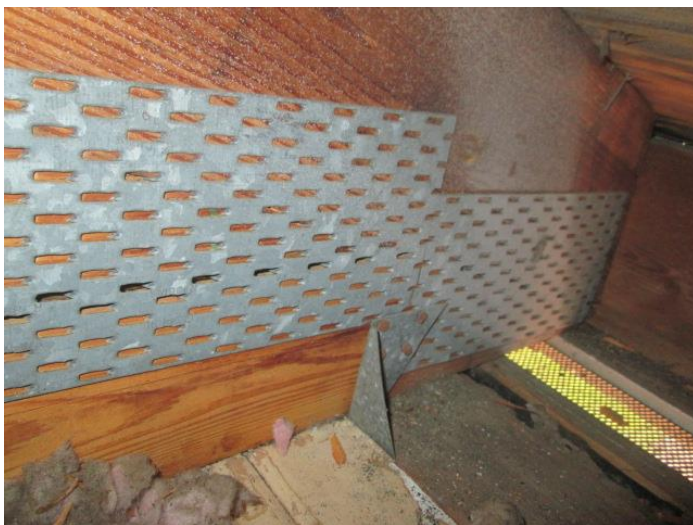
Roof to Wall Attachment

4. **Roof to Wall Attachment:**        **Clips**  
Comments:                                      Inspection verified hurricane clips fastened with a minimum of three nails.

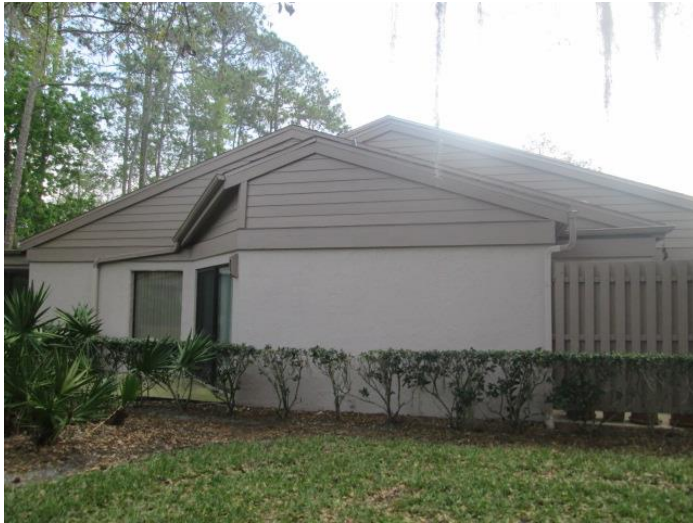
Roof Shape

5. **Roof Geometry:**                      **Other Roof**  
Comments:                                      Inspection verified a gable roof shape.
6. **SWR:**                                      **Yes**  
Comments:                                      SWR was verified at time of inspection. The Secondary Water Resistance verified is a self-adhering peel and stick.
