COMMERCIAL WINDSTORM MITIGATION INSPECTION REPORT (OIR-B1-1802)

East Lake Woodlands Woods Landing Townhomes Unit One
Association, Inc.

10-20 Woods Landing Trail (Building 2)
Oldsmar, FL 34677

As of 3/5/2014

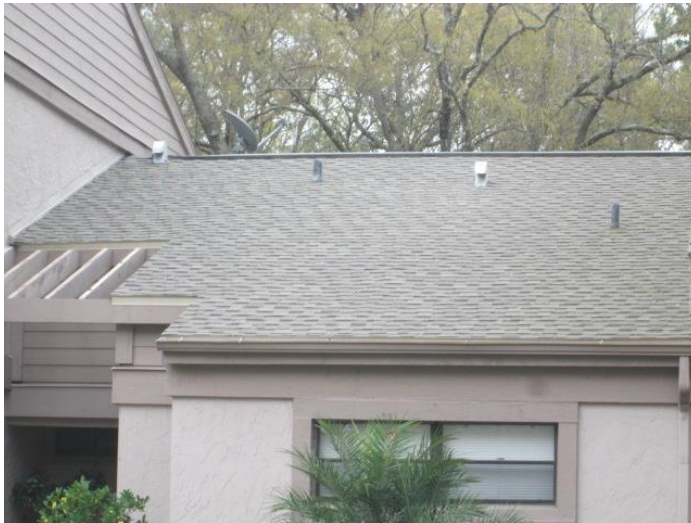
Roof Covering

- 2. Roof Covering:** **FBC Equivalent**
Comments: The roof covering was replaced in 2013. The roof permit was confirmed and the permit number is CW13-04751. This roof was verified as meeting the building code requirements outlined on the mitigation affidavit.

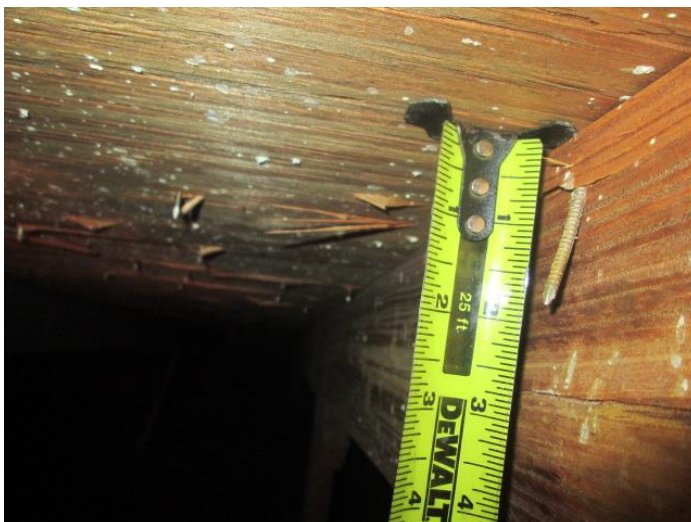
Roof Deck Attachment

- 3. Roof Deck Attachment:** **Level C**
Comments: Inspection verified 1/2" plywood roof deck attached with 8d nails at a minimum 6" on the edge & 6" in the field.

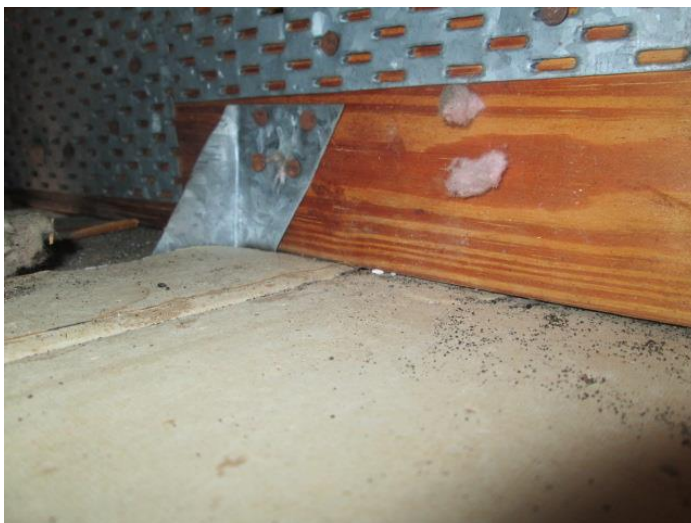
Roof to Wall Attachment

- 4. Roof to Wall Attachment:** **Clips**
Comments: Inspection verified hurricane clips fastened with a minimum of three nails.
- 5. Roof Geometry:** **Other Roof**
Comments: Inspection verified a gable roof shape.

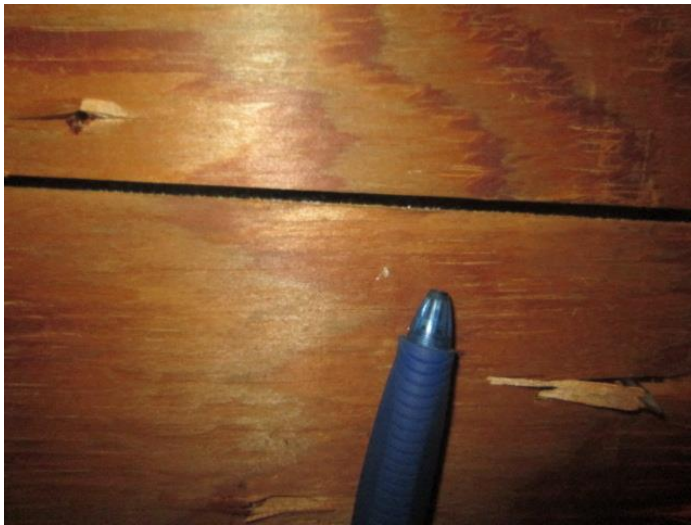
SWR Verified

- 6. SWR:** **Yes**
Comments: SWR was verified at time of inspection. The Secondary Water Resistance verified is a self-adhering peel and stick.
- 7. Opening Protection:** **None or Some Glazed Openings**
Comments: At the time of inspection, no opening protection was verified.
