COMMERCIAL WINDSTORM MITIGATION INSPECTION REPORT (OIR-B1-1802)

East Lake Woodlands Woods Landing Townhomes Unit One
Association, Inc.

15-45 Woods Landing Trail (Building 3)
Oldsmar, FL 34677

As of 3/5/2014

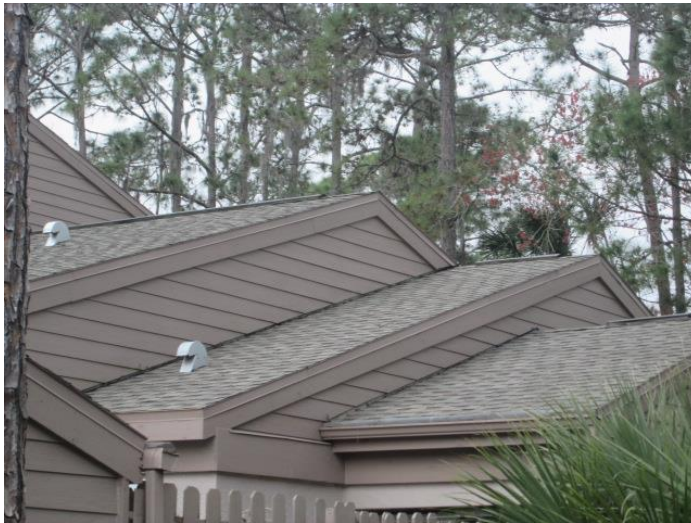
Roof Covering

2. **Roof Covering:** **FBC Equivalent**
Comments: The roof covering was replaced in 2013. The roof permit was confirmed and the permit number is CW13-01868. This roof was verified as meeting the building code requirements outlined on the mitigation affidavit.

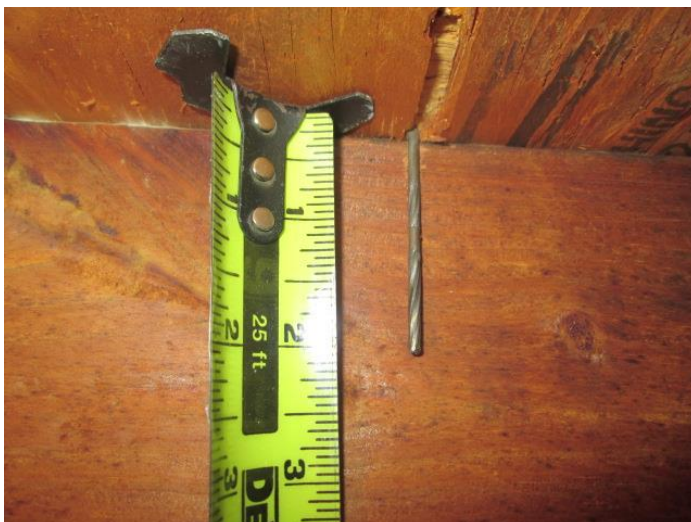
Roof Deck Attachment

3. **Roof Deck Attachment:** **Level C**
Comments: Inspection verified 1/2" plywood roof deck attached with 8d nails at a minimum 6" on the edge & 6" in the field.

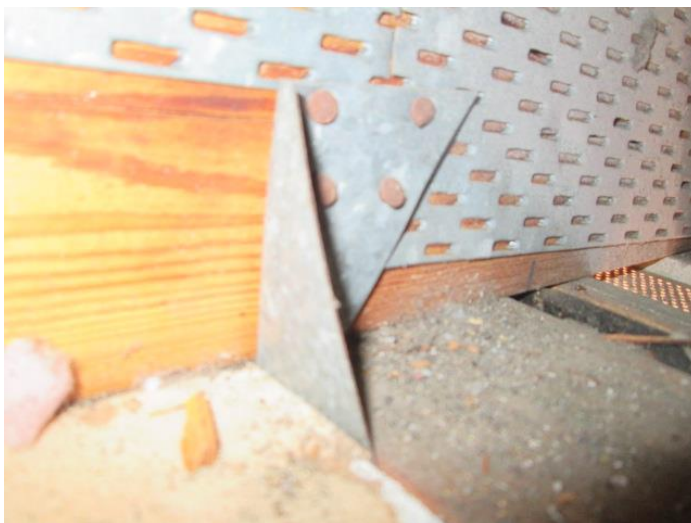
Roof to Wall Attachment

4. **Roof to Wall Attachment:** **Clips**
Comments: Inspection verified hurricane clips fastened with a minimum of three nails.
5. **Roof Geometry:** **Other Roof**
Comments: Inspection verified a gable roof shape.

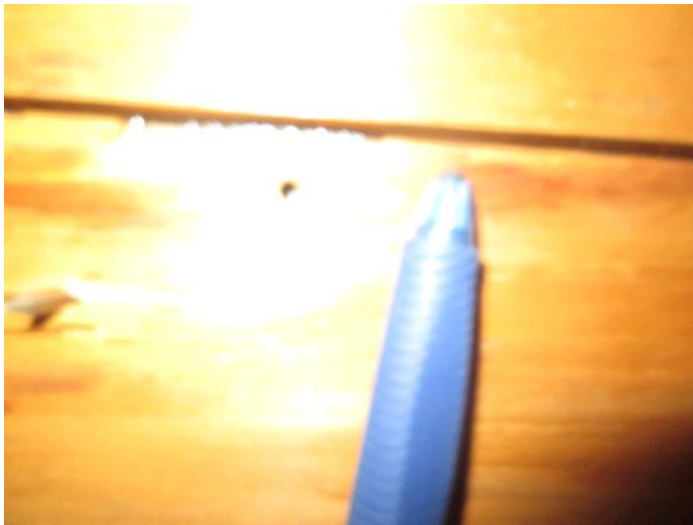
SWR Verified

6. **SWR:** **Yes**
Comments: SWR was verified at time of inspection. The Secondary Water Resistance verified is a self-adhering peel and stick.
7. **Opening Protection:** **None or Some Glazed Openings**
Comments: At the time of inspection, no opening protection was verified.
