COMMERCIAL WINDSTORM MITIGATION INSPECTION REPORT (OIR-B1-1802)

East Lake Woodlands Woods Landing Townhomes Unit One
Association, Inc.

55-85 Woods Landing Trail (Building 4)
Oldsmar, FL 34677

As of 3/5/2014

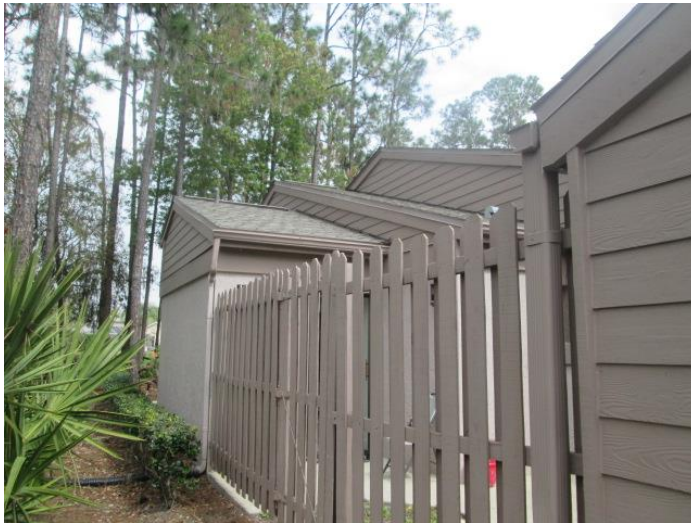
Roof Covering

- 2. Roof Covering:** **FBC Equivalent**
Comments: The roof covering was replaced in 2013. The roof permit was confirmed and the permit number is CW13-00795. This roof was verified as meeting the building code requirements outlined on the mitigation affidavit.

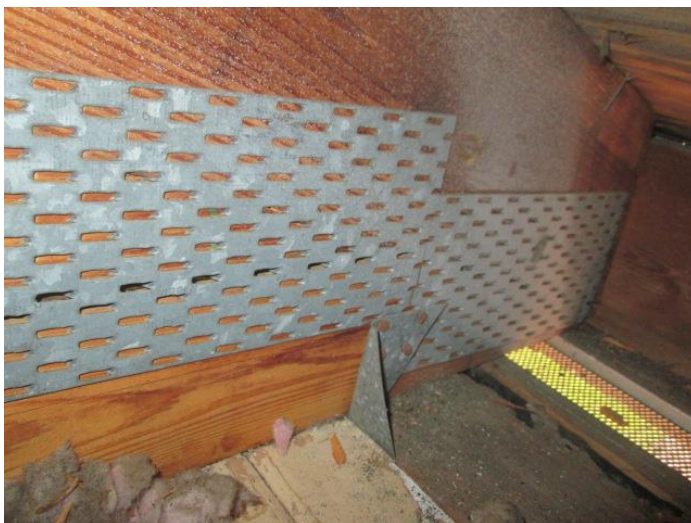
Roof to Wall Attachment

- 4. Roof to Wall Attachment:** **Clips**
Comments: Inspection verified hurricane clips fastened with a minimum of three nails.
- 5. Roof Geometry:** **Other Roof**
Comments: Inspection verified a gable roof shape.

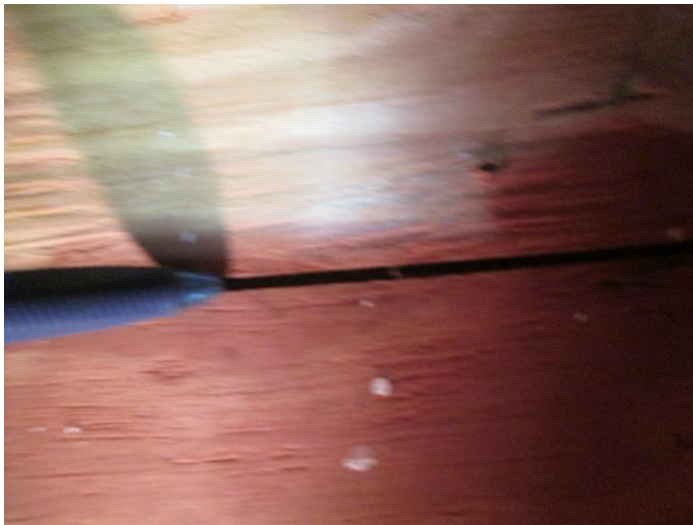
SWR Verified

- 6. SWR:** **Yes**
Comments: SWR was verified at time of inspection. The Secondary Water Resistance verified is a self-adhering peel and stick.
- 7. Opening Protection:** **None or Some Glazed Openings**
Comments: At the time of inspection, no opening protection was verified.
