COMMERCIAL WINDSTORM MITIGATION INSPECTION REPORT (OIR-B1-1802)

East Lake Woodlands Woods Landing Townhomes Unit One
Association, Inc.

95-155 Woods Landing Trail (Building 5)
Oldsmar, FL 34677

As of 3/5/2014

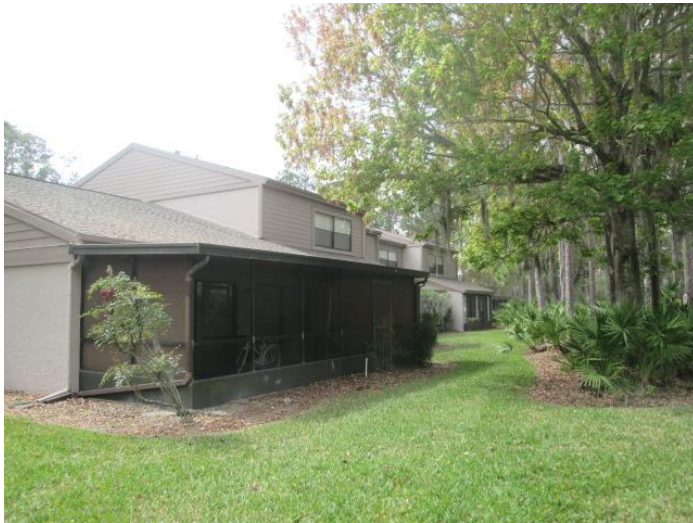
Roof Covering

- 2. Roof Covering:** **FBC Equivalent**
Comments: The roof covering was replaced in 2012. The roof permit was confirmed and the permit number is CW12-09321. This roof was verified as meeting the building code requirements outlined on the mitigation affidavit.

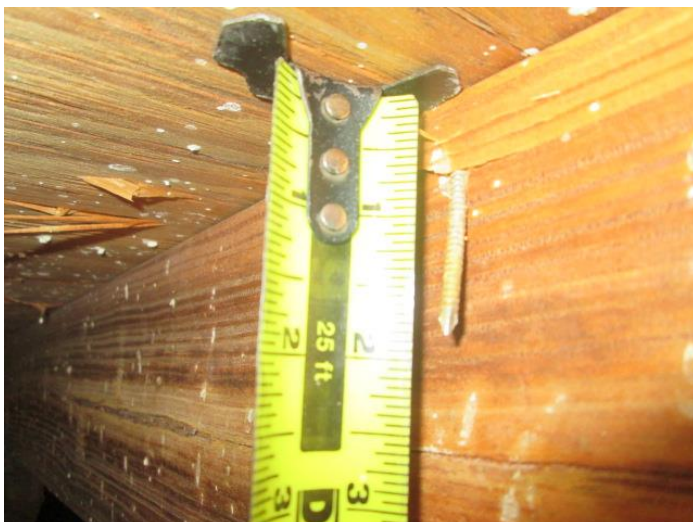
Roof Deck Attachment

- 3. Roof Deck Attachment:** **Level C**
Comments: Inspection verified 1/2" plywood roof deck attached with 8d nails at a minimum 6" on the edge & 6" in the field.

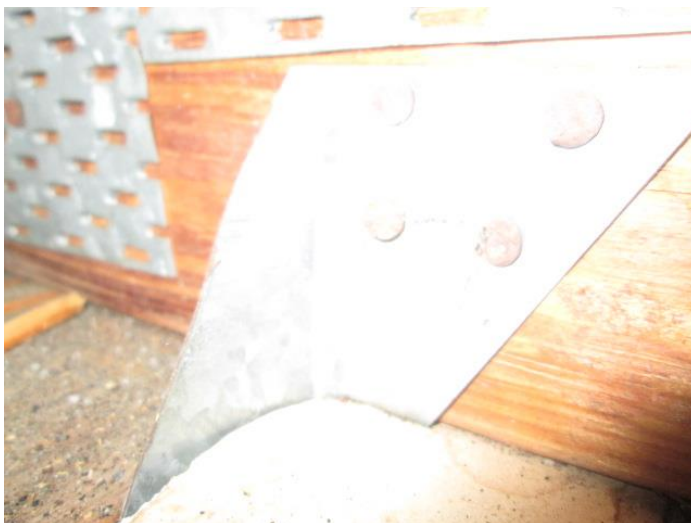
Roof to Wall Attachment

- 4. Roof to Wall Attachment:** **Clips**
Comments: Inspection verified hurricane clips fastened with a minimum of three nails.
- 5. Roof Geometry:** **Other Roof**
Comments: Inspection verified a gable roof shape.

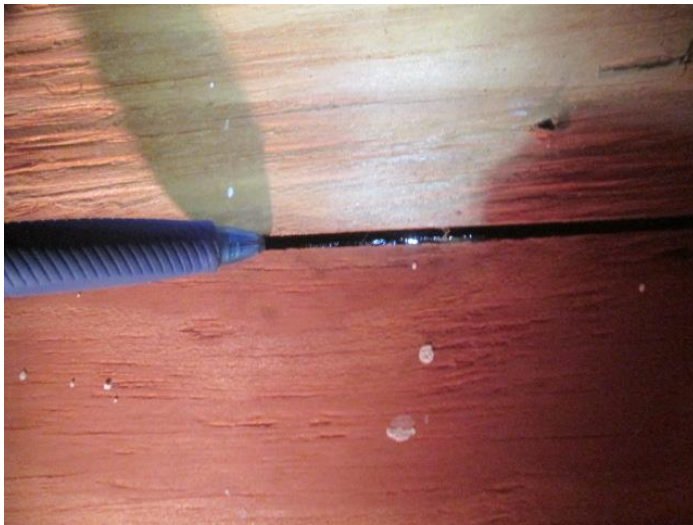
SWR Verified

- 6. SWR:** **Yes**
Comments: SWR was verified at time of inspection. The Secondary Water Resistance verified is a self-adhering peel and stick.
- 7. Opening Protection:** **None or Some Glazed Openings**
Comments: At the time of inspection, no opening protection was verified.
