COMMERCIAL WINDSTORM MITIGATION REPORT

East Lake Woodlands Woods Landing Townhomes Unit One Association, Inc.

COMMERCIAL WINDSTORM MITIGATION REPORT (OIR-B1-1802)

230-260 Woods Landing Trail

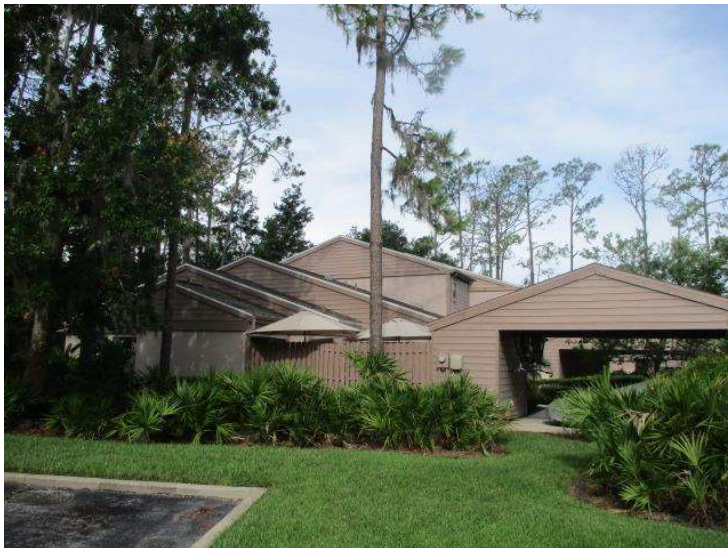
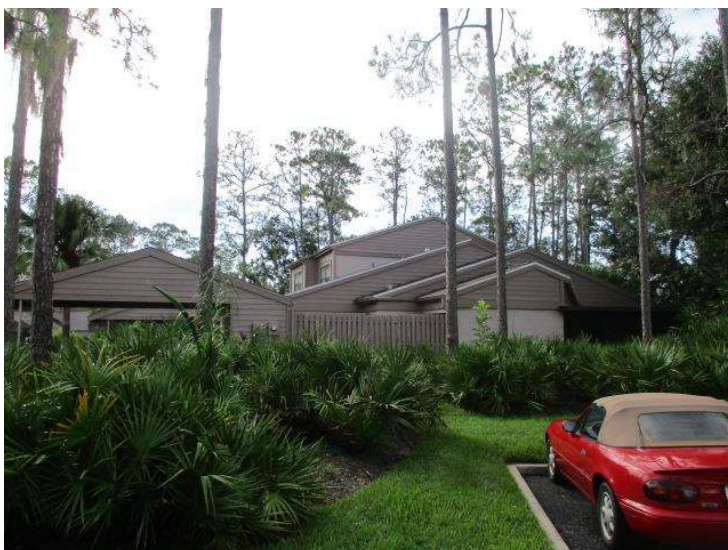
Exterior Elevation

4. **Roof to Wall Attachment:** **Clips**
Comments: Inspection verified hurricane clips fastened with a minimum of three nails.
5. **Roof Geometry:** **Other Roof**
Comments: Inspection verified a gable roof shape.

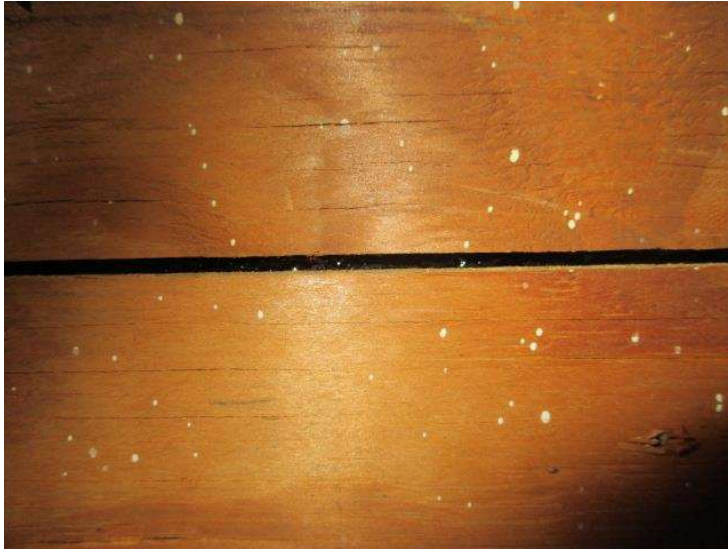
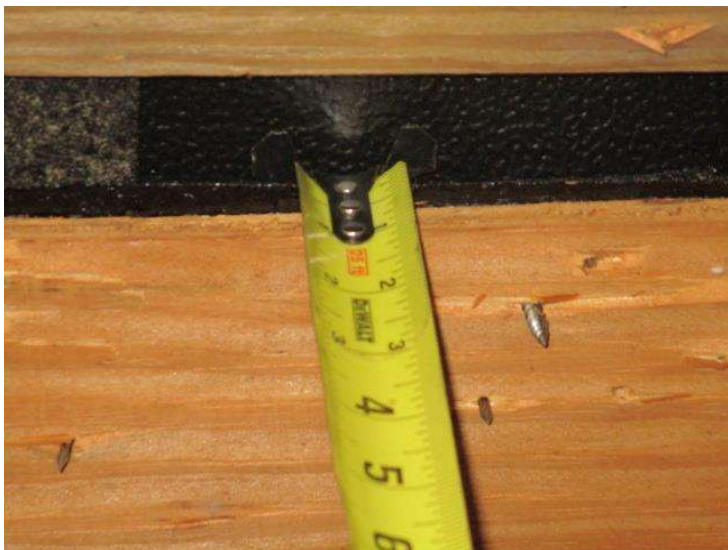
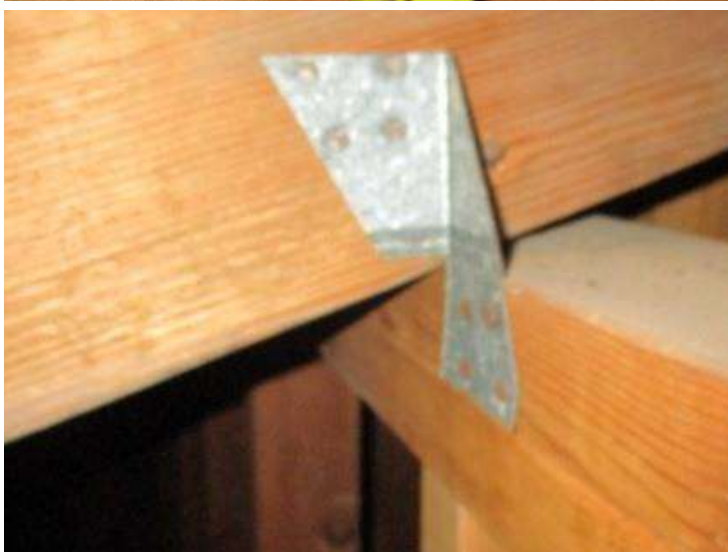
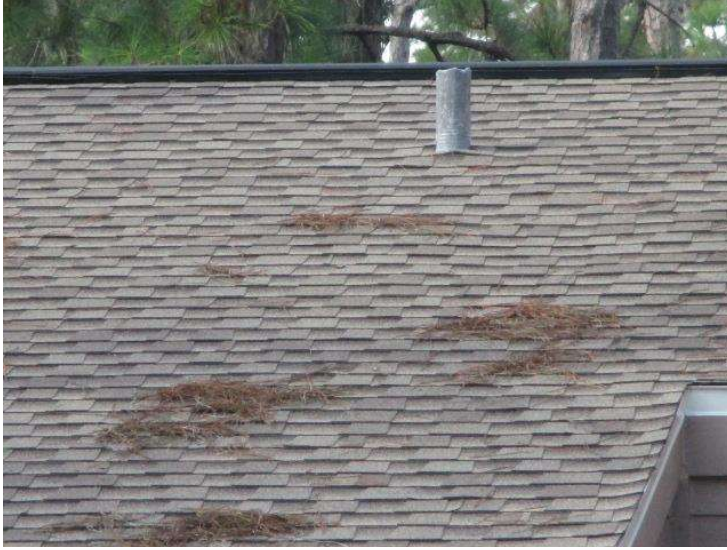
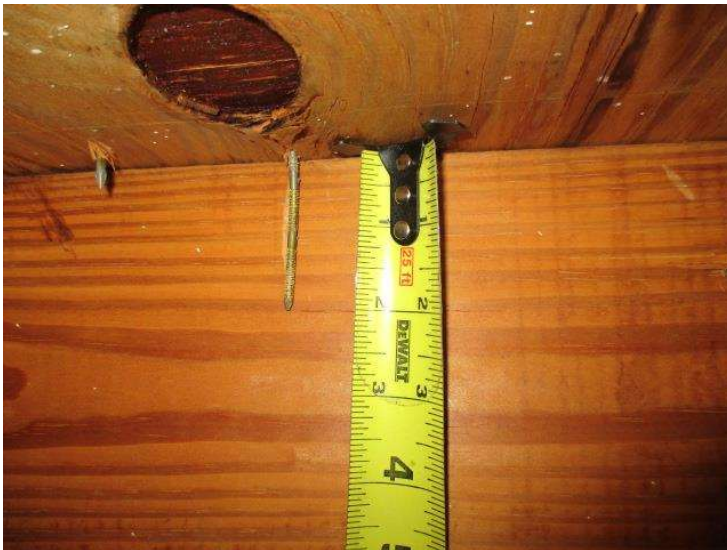
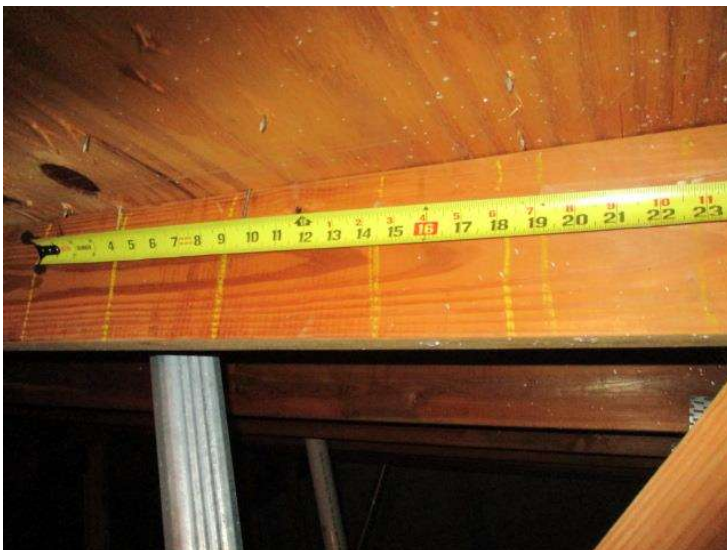
Roof Construction

3. **Roof Deck Attachment:** **Level C**
Comments: Inspection verified 1/2" plywood roof deck attached with 8d nails at a minimum 6" on the edge & 6" in the field.

6. **SWR:** **Yes**
Comments: SWR was verified at time of inspection. The Secondary Water Resistance verified is a self-adhering peel and stick.
7. **Opening Protection:** **None or Some Glazed Openings**
Comments: No opening protection verified at the time of inspection.
