Wind Mitigation Inspection Report

30/40/50/60 Woods Landing Trail

Uniform Mitigation Verification Inspection Form

Inspection Date: 3/07/2024		
Owner Information		
Owner Name: East Lake Woodlands Woods Landing		Contact Person: Beverly
Address: 30/40/50/60 Woods Landing Trail		Home Phone:
City: Oldsmar	Zip: 34677	Work Phone:
County: Pinellas		Cell Phone:
Insurance Company:		Policy #:
Year of Home: 1984 (40 years)	# of Stories: Two	Email: bneubecker@ameritechmail.com

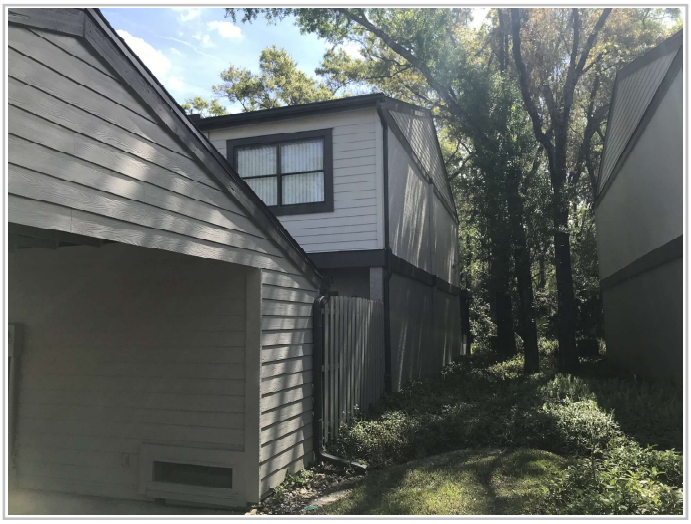
Right Elevation

8d Ringshank Renail

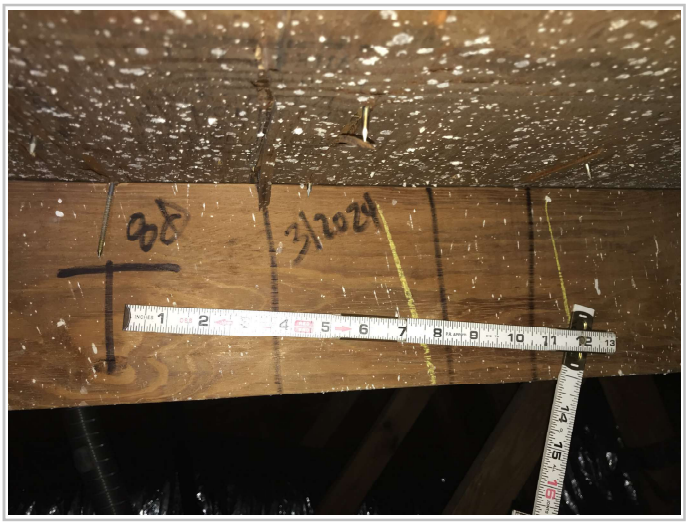
- ☑ C. Plywood/OSB roof sheathing with a minimum thickness of 7/16"inch attached to the roof truss/rafter (spaced a maximum of 24"inches o.c.) by 8d common nails spaced a maximum of 6" inches in the field. -OR- Dimensional lumber/Tongue & Groove decking with a minimum of 2 nails per board (or 1 nail per board if each board is equal to or less than 6 inches in width). -OR- Any system of screws, nails, adhesives, other deck fastening system or truss/rafter spacing that is shown to have an equivalent

8d Nails within 6"

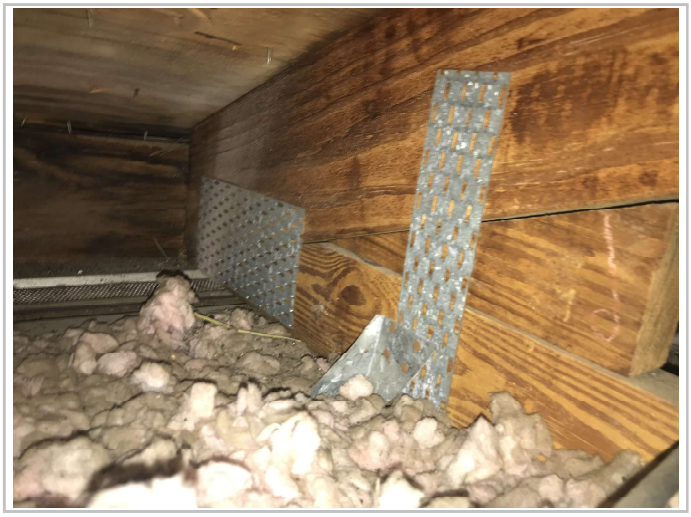
☑ B. Clips

Clips observed

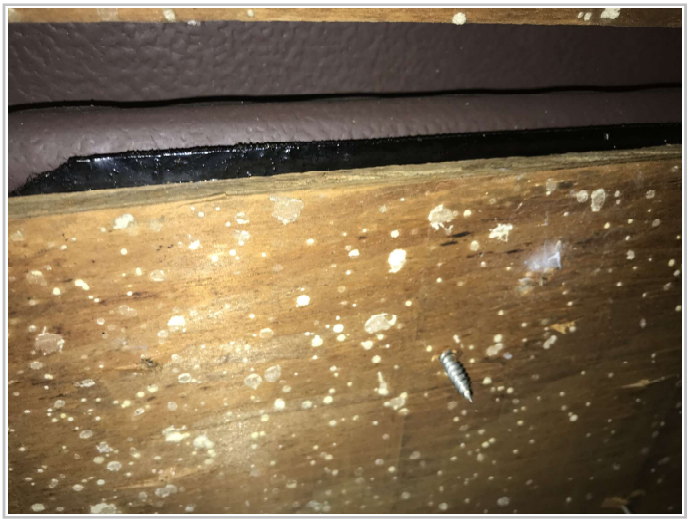
☑ A. SWR (also called Sealed Roof Deck) Self-adhering polymer modified-bitumen roofing underlayment applied directly to the sheathing or foam adhesive SWR barrier (not foamed-on insulation) applied as a supplemental means to protect the dwelling from water intrusion in the event of roof covering loss.

SWR confirmed
