Wind Mitigation Inspection Report

455/465/475/485/495 Woods Landing Trail

Uniform Mitigation Verification Inspection Form

Inspection Date: 3/07/2024		
Owner Information		
Owner Name: East Lake Woodlands Woods Landing		Contact Person: Beverly
Address: 455/465/475/485/495 Woods Landing Trail		Home Phone:
City: Oldsmar	Zip: 34677	Work Phone:
County: Pinellas		Cell Phone:
Insurance Company:		Policy #:
Year of Home: 1984 (40 years)	# of Stories: Two	Email: bneubecker@ameritechmail.com

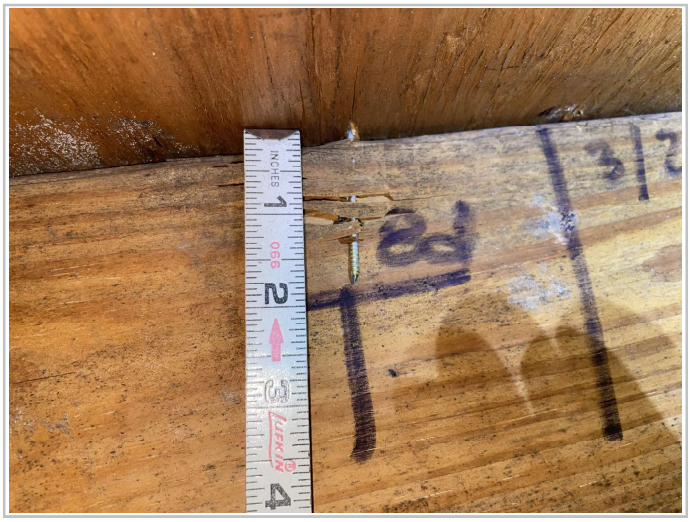
- ☑ C. Plywood/OSB roof sheathing with a minimum thickness of 7/16"inch attached to the roof truss/rafter (spaced a maximum of 24"inches o.c.) by 8d common nails spaced a maximum of 6" inches in the field. -OR- Dimensional lumber/Tongue & Groove decking with a minimum of 2 nails per board (or 1 nail per board if each board is equal to or less than 6 inches in width). -OR- Any system of screws, nails, adhesives, other deck fastening system or truss/rafter spacing that is shown to have an equivalent

8d Ringshank Renail

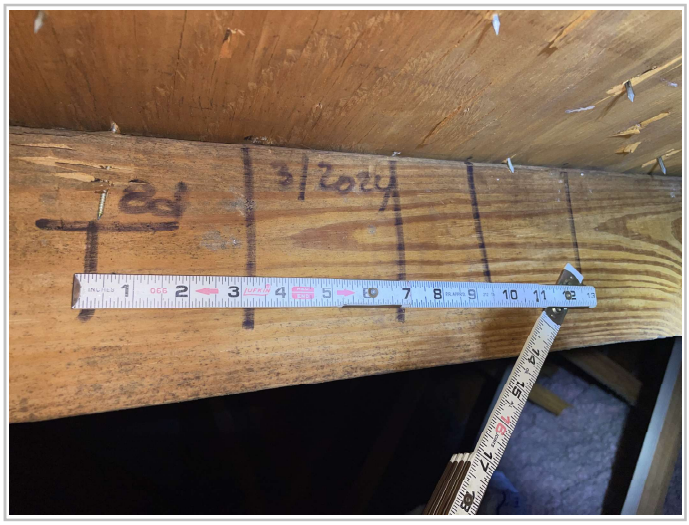
8d Nails within 6"

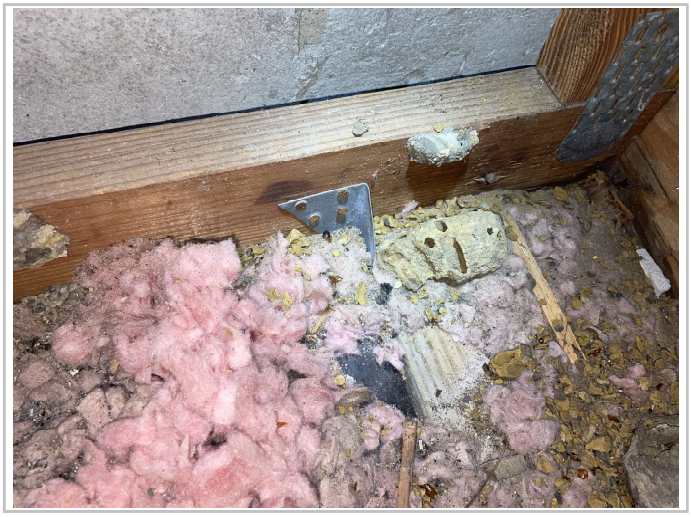
☑ B. Clips

Clips observed

SWR confirmed
