Wind Mitigation Inspection Report

95/105/115/125/135/145/155 Woods Landing Trail
Oldsmar, Florida 34677

Uniform Mitigation Verification Inspection Form

Inspection Date: 3/07/2024		
Owner Information		
Owner Name: East Lake Woodlands Woods Landing		Contact Person: Beverly
Address: 95/105/115/125/135/145/155 Woods Landing Trail		Home Phone:
City: Oldsmar	Zip: 34677	Work Phone:
County: Pinellas		Cell Phone:
Insurance Company:		Policy #:
Year of Home: 1984 (40 years)	# of Stories: Two	Email: bneubecker@ameritechmail.com

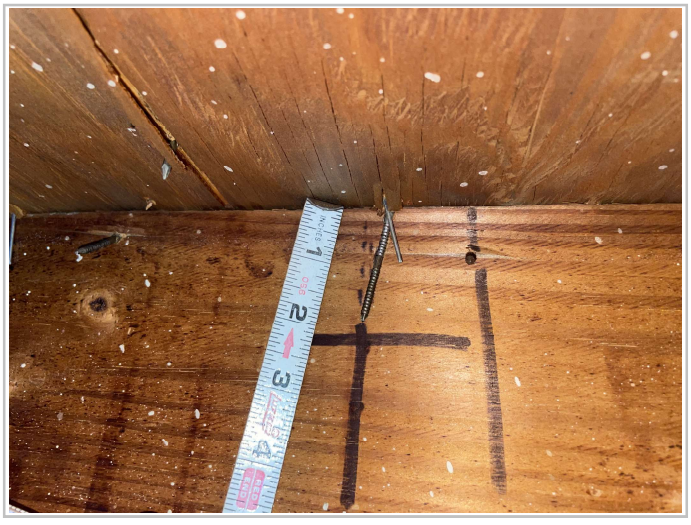
8d Ringshank Renail

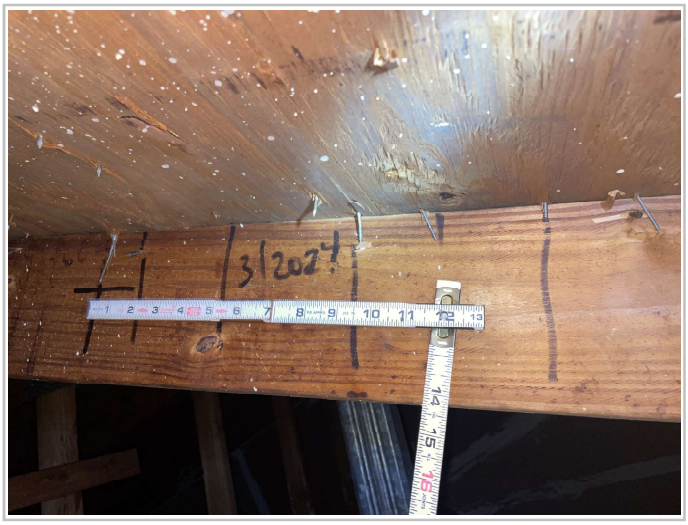
8d Nails within 6"

Clips observed

SWR confirmed
